Welcome to the 30th Steward Observatory Safety Committee Meeting

Room N305 November 28, 2017
9:00 AM

Update on Indoor Air Quality Issues

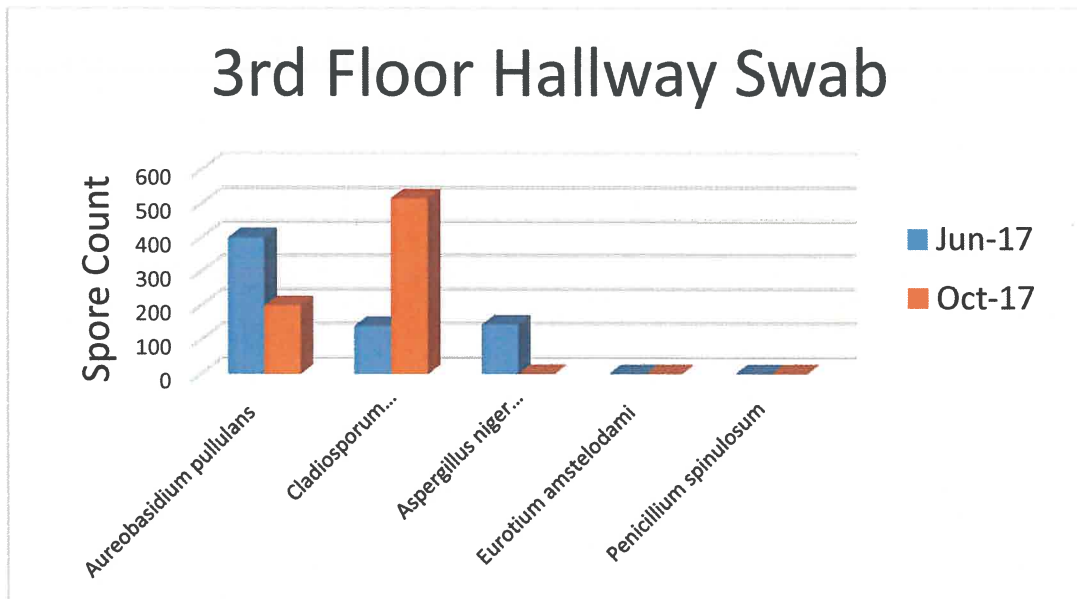
Figure 2: 3rd Floor Swabs

In the 3rd Floor Main Hallway, we found *Aureobasidium pollulans* and *Cladosporium sphareospermum* from Group 1 and *Cladosporium cladosporoides I* and *Cladosporium cladosporoides II* from Group 2. The ERMI Score is 1.5, considered by the lab as a Moderate Level 3. We can see that the ERMI score is lower than the ERMI score in the first sampling event (2.6). The highest mold values found in the 3rd floor hallway are part of the Group 1 organisms, molds commonly associated with water damage. See Figure 2 for visual representation of this swab sampling results:

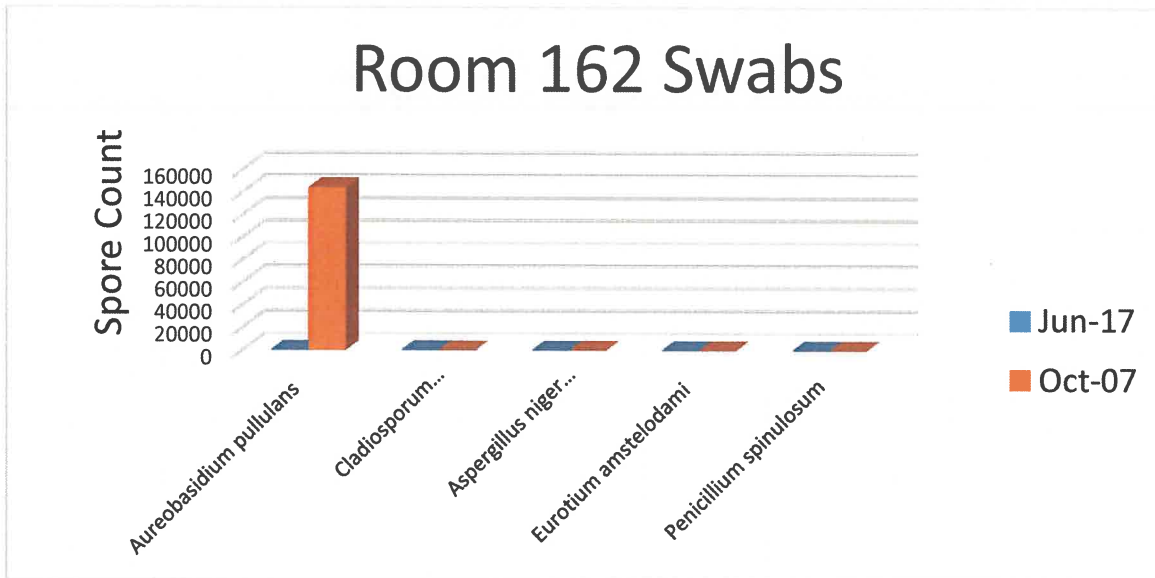
Figure 3: Room 162 Swabs

In Room 162, we found *Aureobasidium pullulans* and *Aspergillus niger* from Group I. We also found *Cladosporium cladosporoides* I from Group II. The ERMI Score is 4.8, considered by the lab as a Moderate Level 3 as well but close to High Level 4. The ERMI score was higher than the ERMI score in the first sampling event (3.4) in this same area. A high score of 144,000 sp Eq of *Aureobasidium pullulans* was found, but it is still lower than the outside value of 198,000 sp Eq. See Figure 3 for visual representation of this swab sampling results:

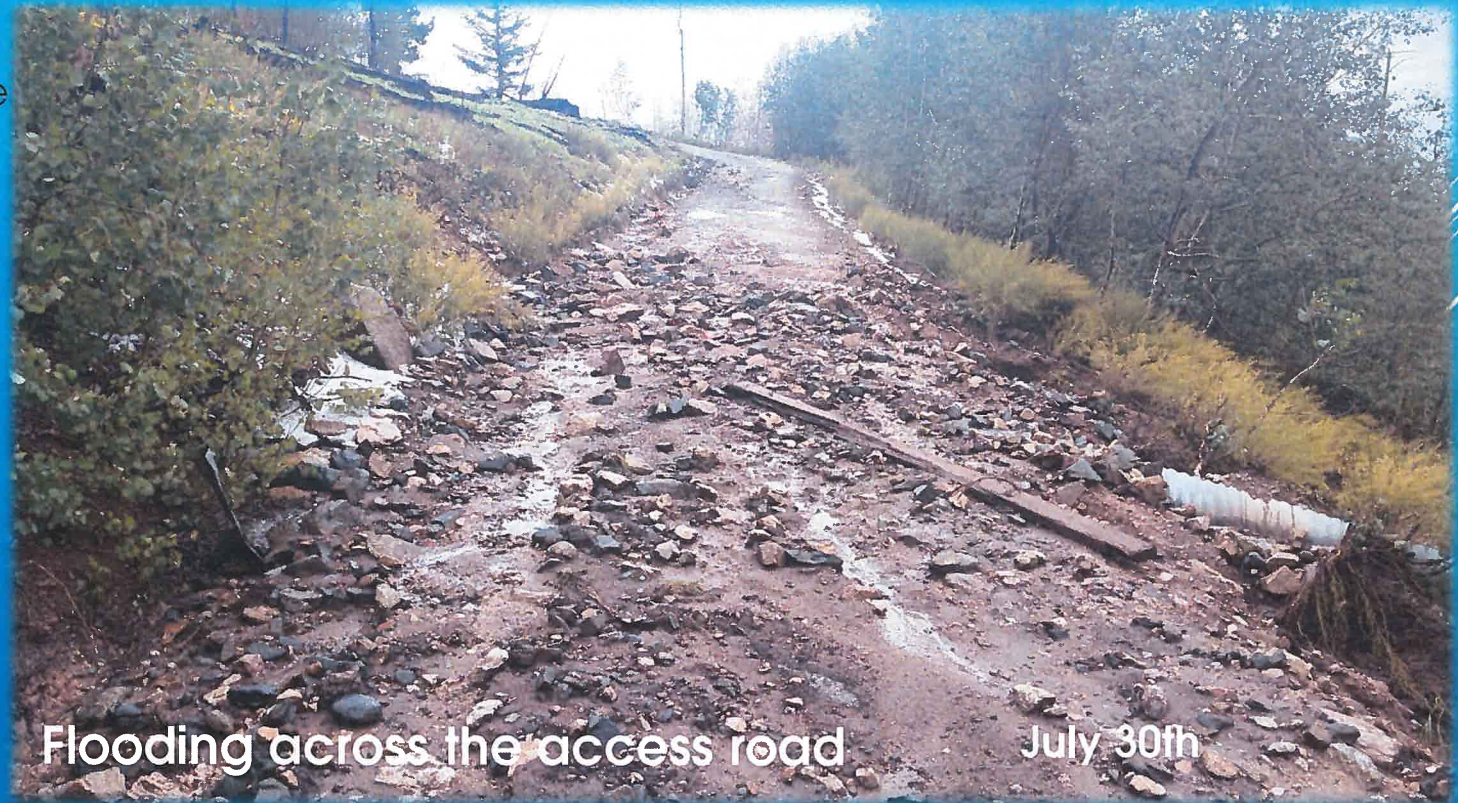
Flooding across the access road

Plugged culverts caused runoff to flow over roadways causing major damage to all roads

With ground cover burned away, even light rains cause big problems very quickly!

One way access road repairs caused periodic traffic delays
