THE UNIVERSITY OF ARIZONA—TUCSON, AZ.
STEWARD OBSERVATORY ANNEX BLDG. 64
1540 E 2ND STREET. INSTALL 3 NEW
MAN GATES WITHIN BLDG. HALL COMPLEX
ONE ON THE NORTH, ONE SOUTH, AND
ONE SOUTHWEST.

EXISTING/NEW SITE PLAN

ELEVATIONS/DETAILS

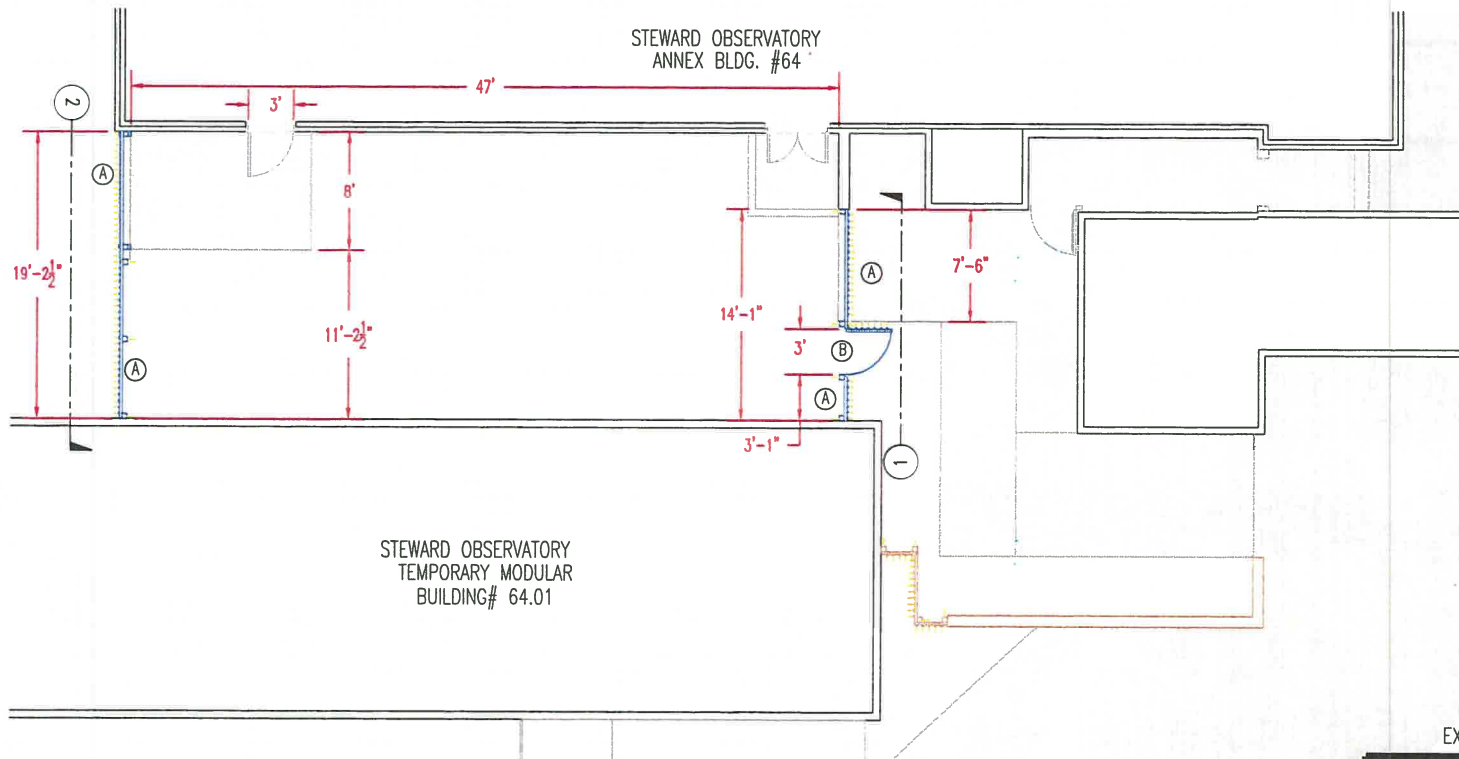
EXISTING/NEW SITE PLAN
SCALE: 1/8" = 1'

- DEMOLITION NOTES:**
- (A) INSTALL NEW WROUGHT IRON FENCING HERE, FENCING TO BE:
 - 4"x4" STEEL POSTS(HEIGHT WILL VARY, SEE ELEVATIONS)...
 - 2"x2" STEEL HORIZONTAL SPANS...
 - 1"x1" STEEL PICKETS SET @5"O.C...
 - (B) INSTALL NEW WROUGHT IRON DOOR HERE, DOOR TO BE:
 - 2"x2" STEEL FRAMING...
 - 1"x1" STEEL PICKETS SET @5"O.C...
 - ADD HANDLE LEVER LOCKSET TO DOOR...
 - ADD WIRE MESH BLOCK AROUND DOOR HANDLE...
 - DOOR WILL BE 3'-0" WIDE...
